North Anna Power Station Earthquake Assessment

2012 Nuclear Reactor Technologies Summit

March 20, 2012

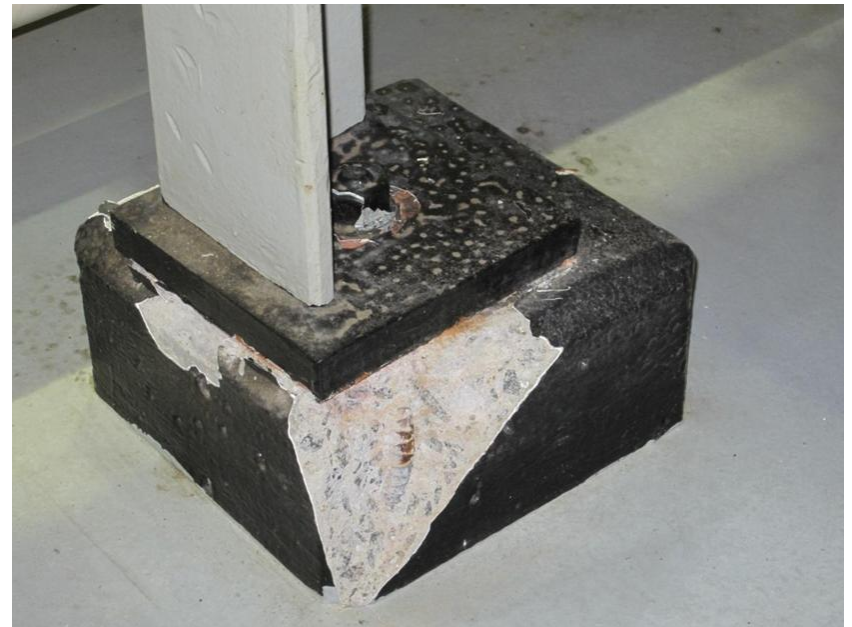
Non-Safety Related
Demineralizer
Tanks

Base Pedestal

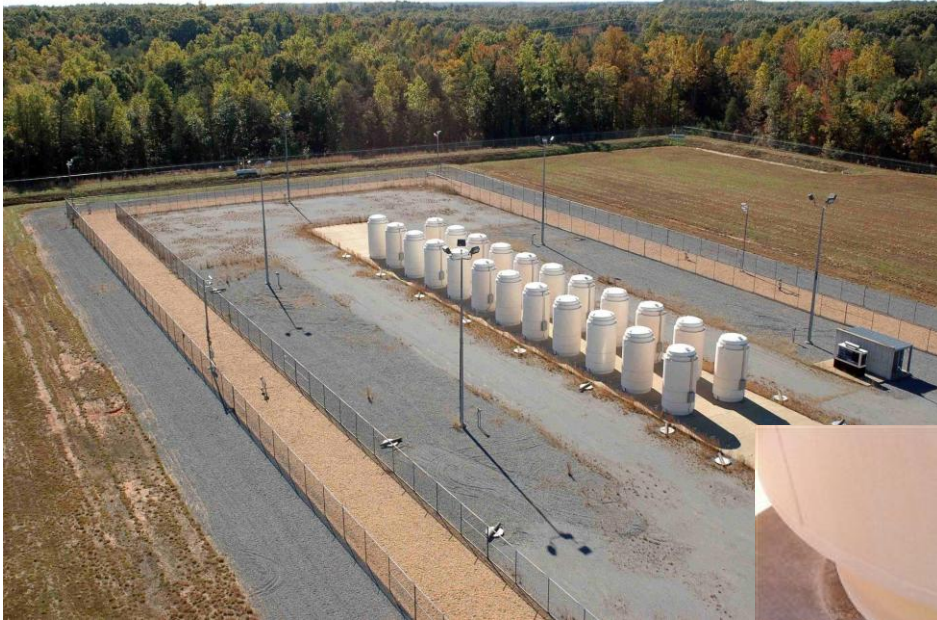
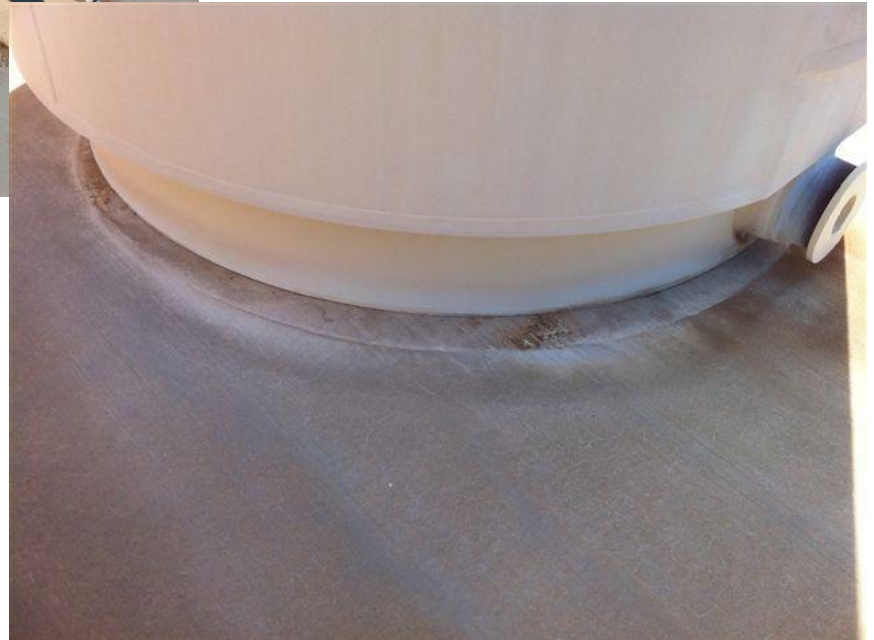
Dry Cask Storage

Casks moved
between 1 and
4½ inches

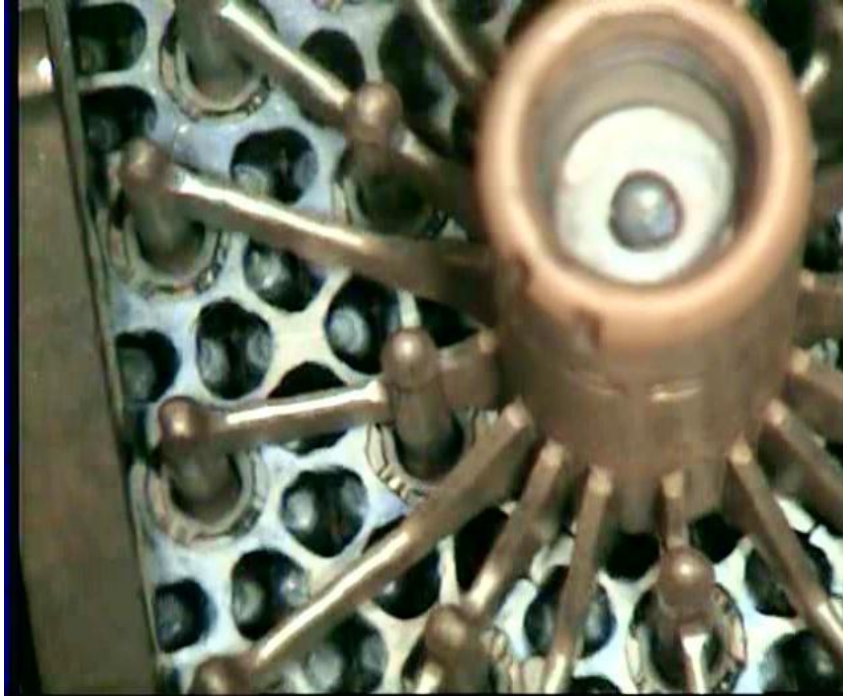
Visual inspection of RCCA hubs

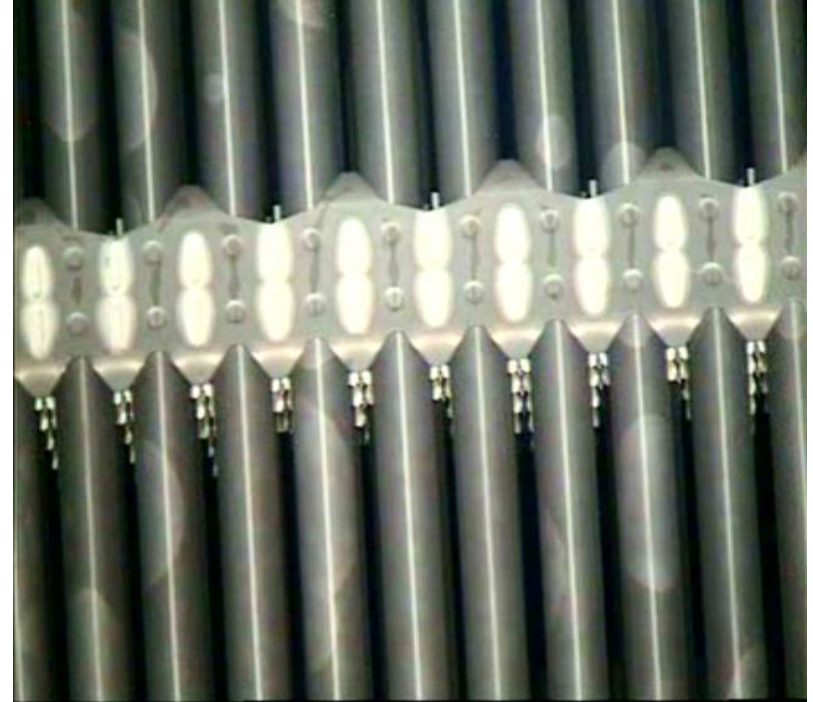
Examination of underside of
a mid-span mixing grid

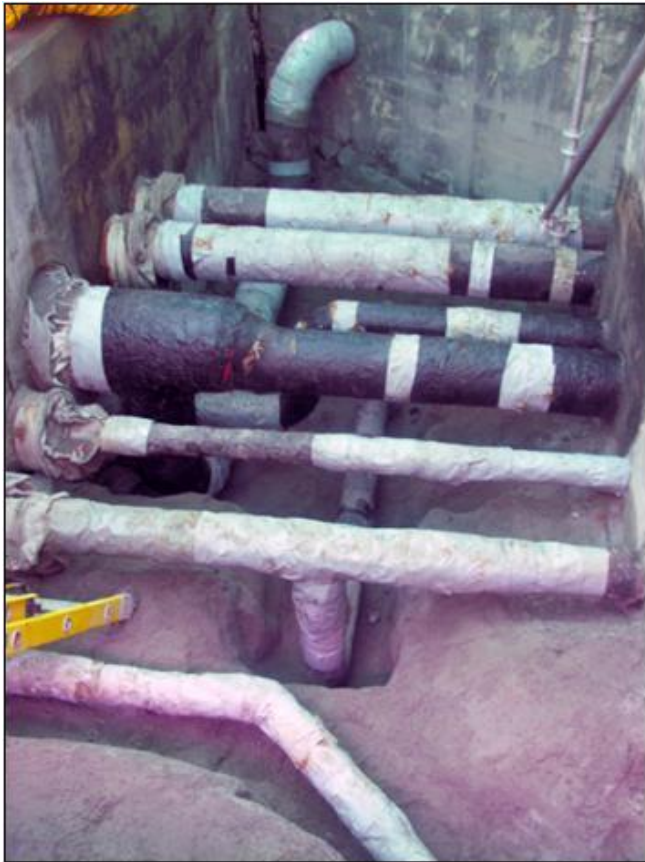
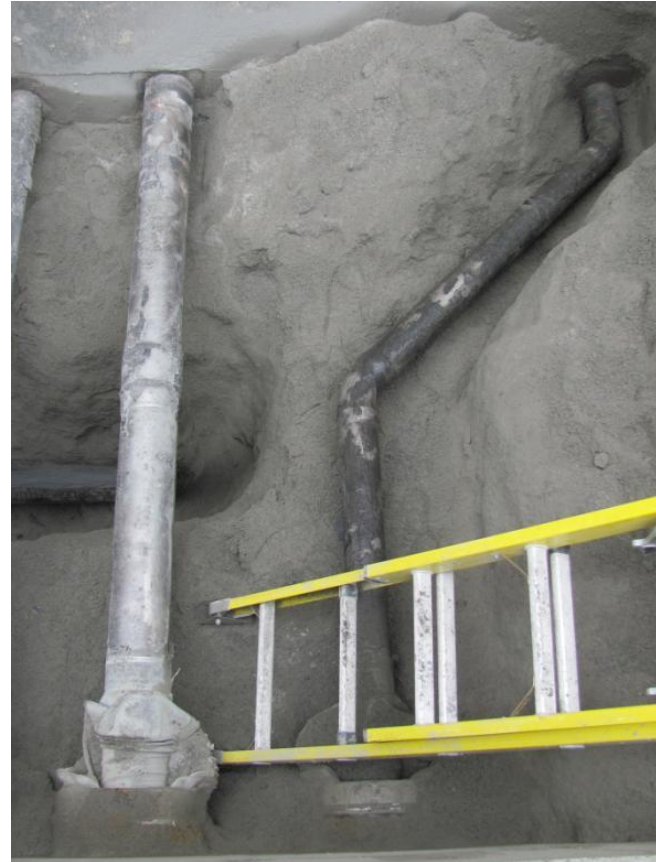
Buried Piping

~ 100 ft of safety-related buried pipe visually inspected
with wall thickness verified by Ultrasonic Testing

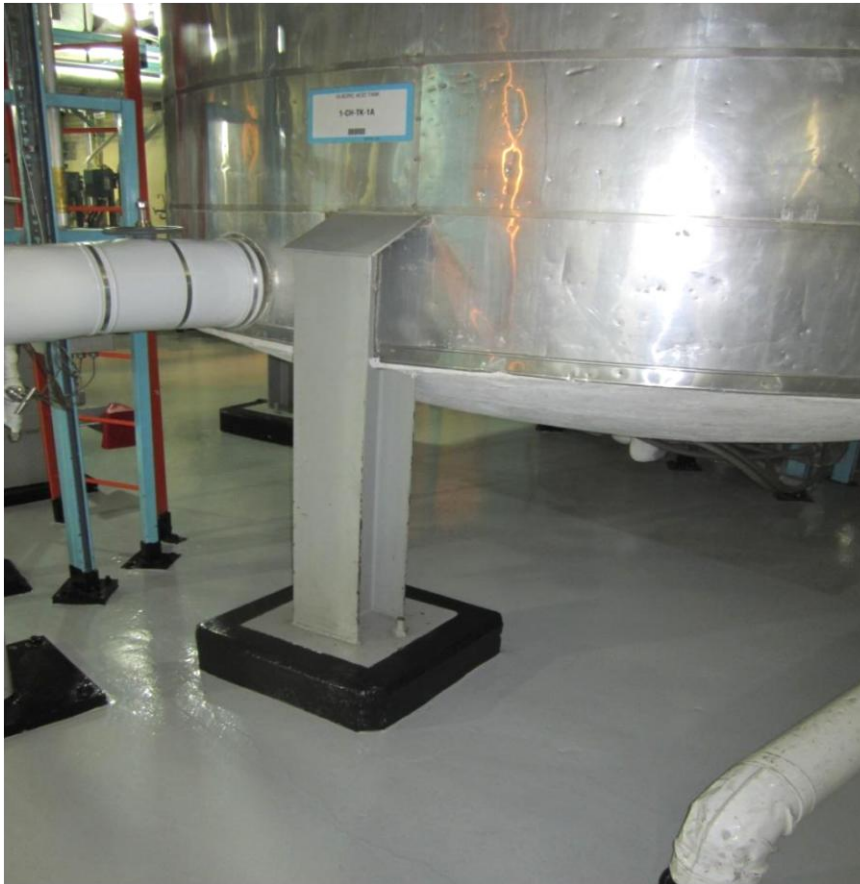
Boric Acid Storage Tank

HCLPF value
= 0.21
No seismic
damage
identified
